## ***OCJ GROUPS PROFILE***

***OCJ GROUPS LTD***

### SERVICES & PROJECTS

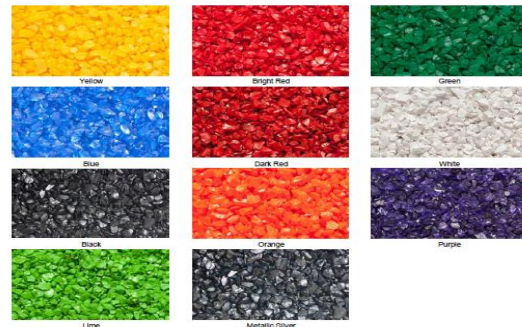
Coloured Range: .3mm | .8mm | .8-15mm

| 1.5-2.5mm | 2.5-5mm | 5-10mm

*Safetygrip aggregates are available in a wide range of colours and can be used for traffic awareness for a wide range of criteria, hazardous and dangerous intersections, traffic black spots, roundabouts, winding roads and bends, changing of speed zones, bus lanes, cycle lanes, pedestrian walkways, highlighting carriageways and parking bays, pathways as well as driveways.*

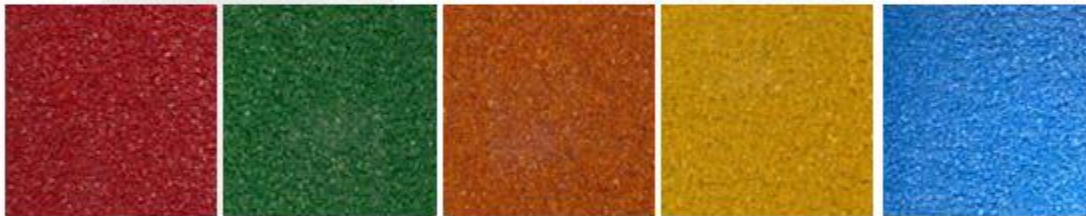
1- 3 mm Synthite® – Standard Traffic Colors Red, Green, Orange, Yellow & Blue

Synthite® is a 100% recycled, Australian developed colorless synthetic aggregate. Testing was carried out to determine the retention and durability of colour after simulated traffic wear tests and to compare its performance with existing products.

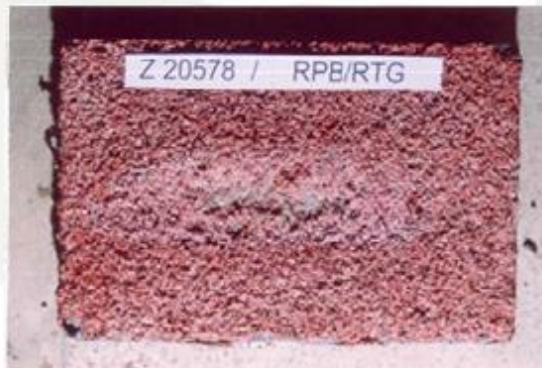
Client Reference RPB/RTG Red

After scuffing, 500 wheel passes, standard condition at 45°C

No faults or abnormalities were observed
